1 Summary

This document details how to upgrade the firmware of a Unidrive M200-M400. This includes upgrading control and power firmware via Unidrive M Connect.

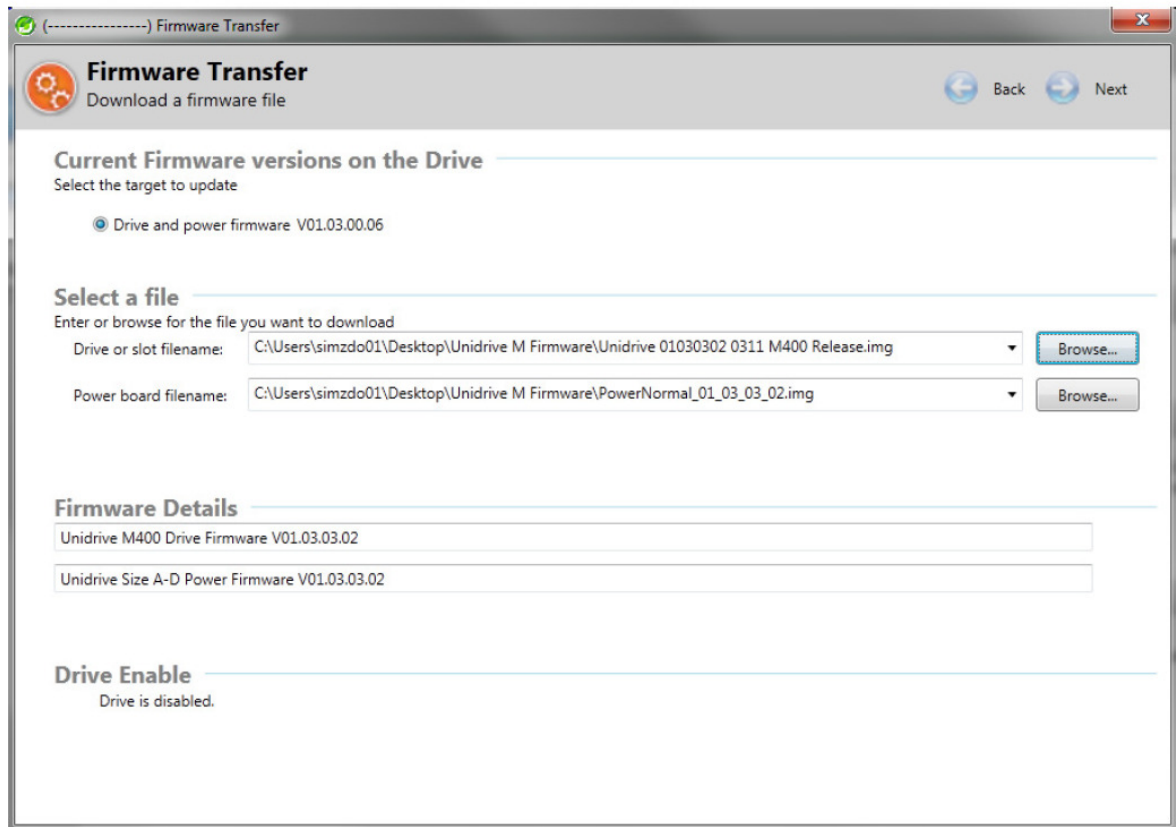
Once connected to the required drive, please click on the “Change Firmware” button. This will open up a new dialog box as shown below:

Under the “Select a file” section, please select the firmware files that are required (drive and power). All firmware files will have a file extension of “.img” E.g. Unidrive 01030302 0311 M400 release.img.

Once the appropriate firmware files are selected, Unidrive M Connect will detect the type of file e.g. drive control board firmware. Please note that the drive must be disabled to continue with the firmware upgrade.

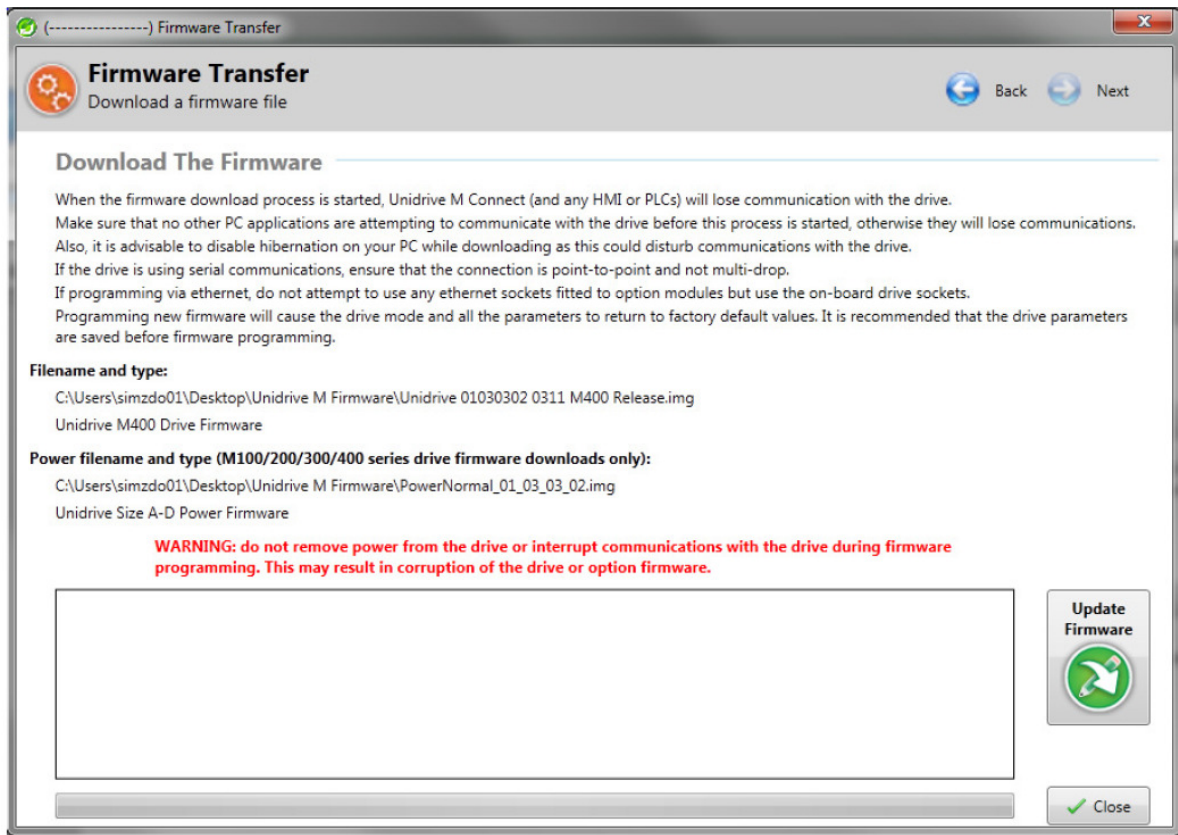
Then click on the Next button on the top right corner and this will bring up the box shown below:

To begin the firmware upgrade, please click on the “Update Firmware” button on the right hand side. This will then automatically download the new firmware to the appropriate target and reset it.
